**City of Glendale
Reconnaissance Survey and
Historic Context Statement
Of Craftsman Style Architecture
2006-2007
Certified Local Government Grant**

October 2007

GalvinPreservationAssociates

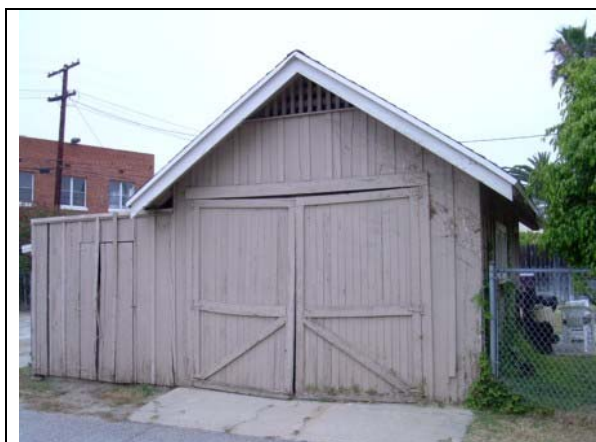
Figure 4: One-car garage for 215 N. Everett Street located at the end of a driveway (built in 1921)

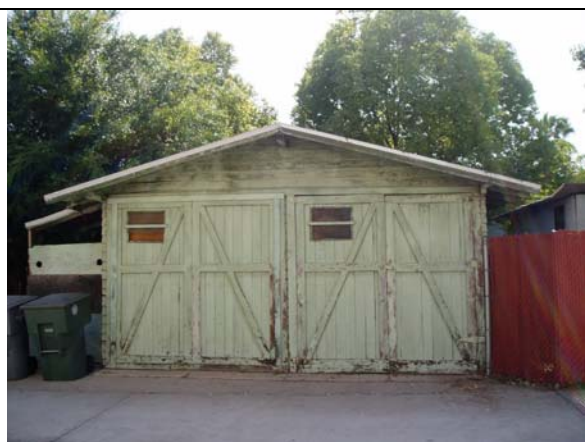
Figure 5: Two-car garage for 534 N. Kenwood Street that faces onto the rear alley (built in 1913)

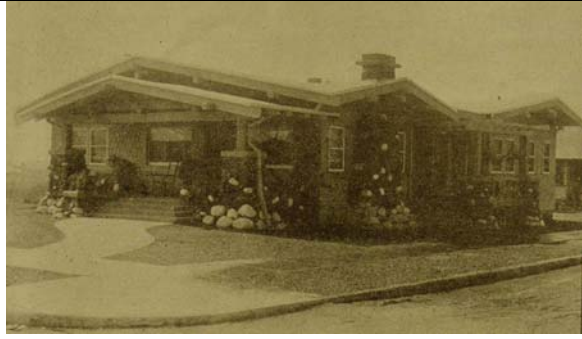
Figure 8: L. G. Dodge House at 1308 Chestnut Street designed and built by Robert P. McMullen ("Harvard Apartments," *Glendale Evening News*, Fall, 1914, 8).

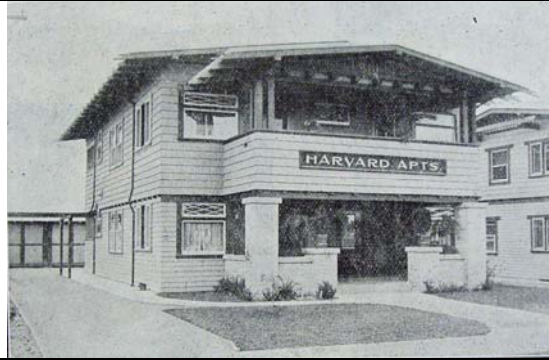
Figure 9: Apartment building constructed by owner and builder Bert T. Anderson in 1913; it boasted to be the first flats to have open screen sleeping rooms, built-in refrigerators and other conveniences of a bungalow ("Harvard Apartments," *Glendale Evening News*, Fall, 1914, 8).

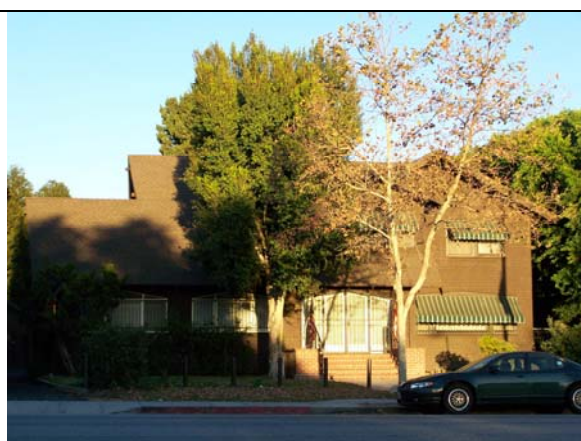
Figure 13: Possibly a Charles E. Shattuck designed Craftsman residence at 614 S. Central Avenue

architect designed and were certainly more substantial. Charles E. Shattuck was an example of such an architect. Shattuck lived in Glendale, and had his architectural office in downtown Los Angeles. He and his family were also heavily involved in Glendale society. Shattuck designed the Craftsman style Toll House located at 1521 N. Columbus Avenue for socially prominent Charles H. and Eleanor Toll around 1912 (see Figure 12). This residence is one of the finest examples of the Craftsman style in Glendale today. Shattuck also designed the Mission Revival Glendale Country Club five years earlier, as well as the First Presbyterian Church at Central and Tropico Avenues, in what was then the community of Tropico, which was annexed by Glendale in 1911. Many of his commissions, however, were residential, often in the Craftsman style. Other substantial homes he created at that time were two-story, nine room residences for J. W. Inler at the southwest corner of Columbus Avenue²⁴ and Riverdale Drive,²⁵ and George Kissenbury at Central Avenue and Riverdale Drive. The Toll House still stands, and 614 S. Central Avenue is possibly the Kissenbury residence (see Figure 13). The Inler House has been demolished.

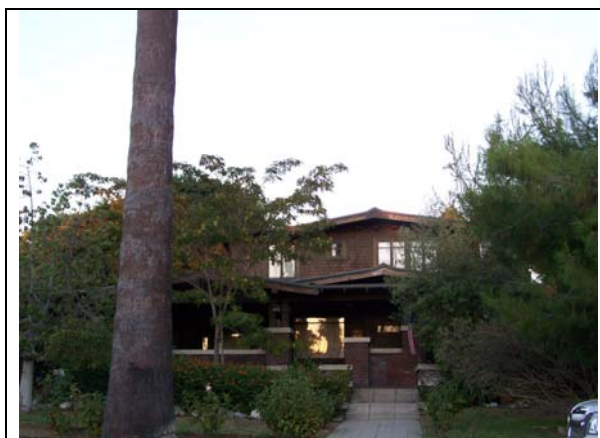
Figure 15: Alfred F. Priest designed Craftsman style residence at 1330 N. Louise Street (built in 1915)

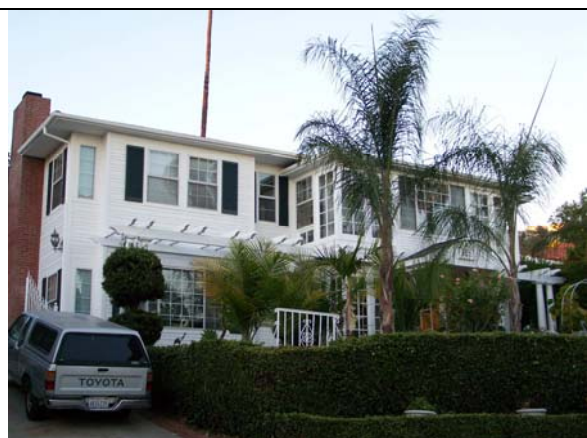
Figure 16: Alfred F. Priest designed Craftsman style residence at 1545 Cedarhill (built in 1921)

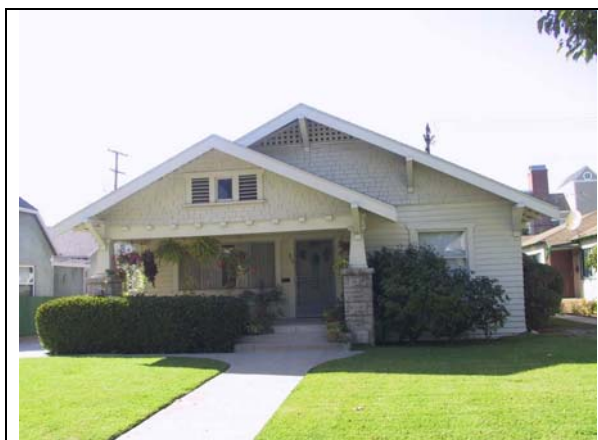
Figure 18: 515 N. Isabel Street (built in 1914)

This is the most commonly represented Craftsman sub-style in Glendale, and is what most people envision when they think of a Craftsman home. The typical Bungalow is a one-story house with low-pitched broad gables; it can be double-front gabled, side gabled or cross gabled. A lower gable usually covers an open or screened porch and a larger gable covers the main portion of the house. In larger bungalows the gable is steeper, with the addition of cross gables and/or dormers. Rafters, ridge beams and purlins extend beyond the wall and roof. Chimneys are of cobblestone or rough-faced brick. Porch railings can also be of the same material, as well as wood or ornamental concrete blocks. Shingled porch railings often terminate with a flared base. The porch pedestals are often battered. Wood shingles and/or horizontal wood boards are the favorite exterior finish found in Glendale, although gunite and brick can be found in other parts of the state and country. Exposed structural members and trim work usually are painted but the shingles were traditionally left in a natural state or treated with earth-tone stains (although many of these shingles have since been painted).

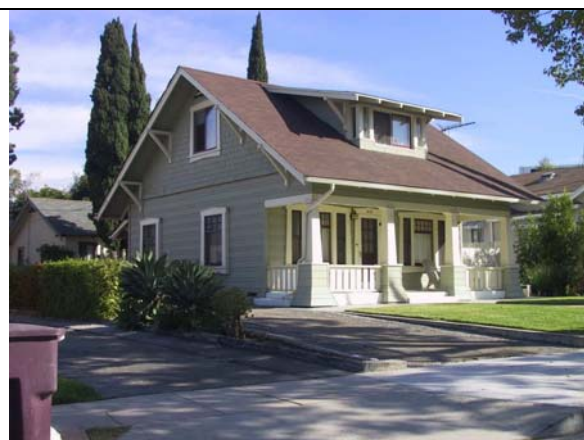
Figure 19: 1415 E. California Avenue (built in 1913)

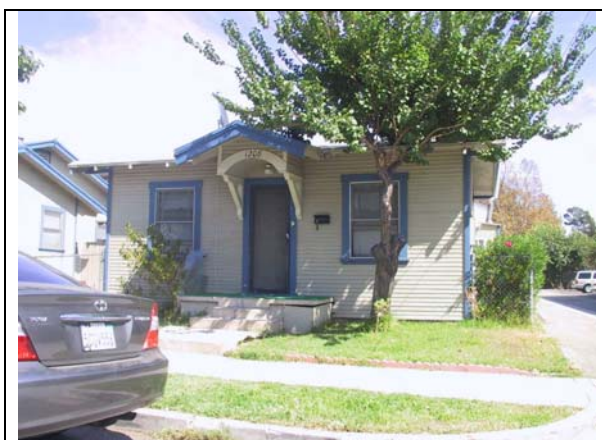
Figure 20: 1208 Boynton Street (built in 1922)

This is the smallest and most modest of the Craftsman sub-styles located in Glendale. In many communities, this sub-style is also identified as a “worker’s cottage.” This style is one-story in height with a compact rectangular plan. There is a centralized main entrance with a simple partial-width porch sheltered by a front gabled roof. The entry is typically flanked by windows, often creating a symmetrical façade. Other characteristics are a side-gabled low-pitched roof, horizontal wood siding and other Craftsman stylistic details (exposed rafter tails, wide window and door casings, triangular knee brace supports, etc.).

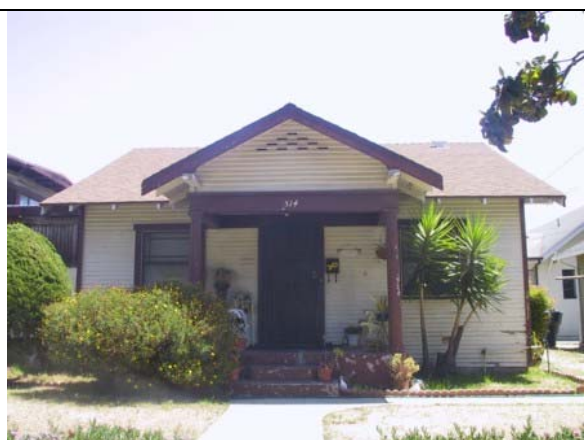
Figure 21: 514 Granada Street (built in 1923)

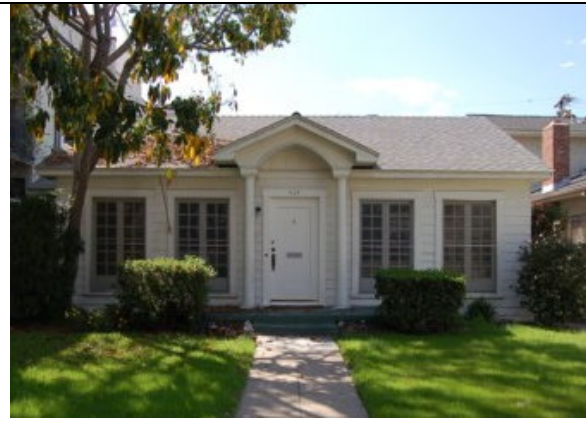
Figure 22: 529 N. Jackson Street (built in 1919)

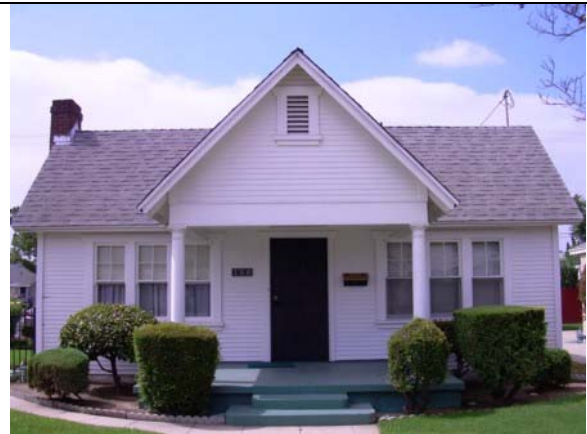
Figure 23: 500 Salem Street (built in 1922)

roof. This roof can also be more substantial with a steeper pitch, as illustrated in Figure 23. There can also be an arch located within the gable. The porch roof is often supported by Tuscan order columns. The front porch sometimes features a pergola on each side of the entry (or, in some cases, just one side). The windows can consist of the double hung sash, fixed and/or casement sash typically associated with the Craftsman style, or can be taller French windows. The front door is more representative of a Colonial Revival home, made of solid wood, painted and with multiple panels (or sometimes only a single large panel).

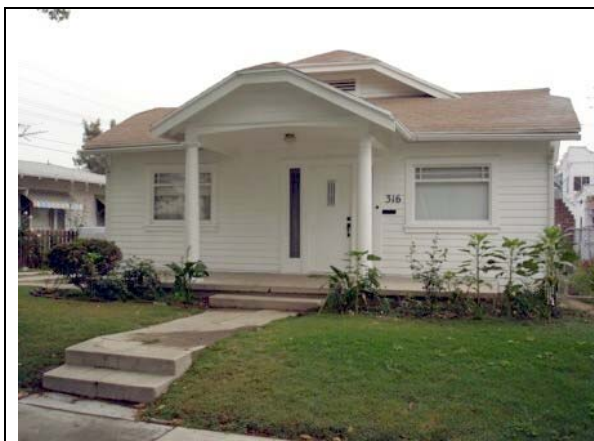
Figure 24: 316 W. Acacia Avenue (built in 1923)

The *Clipped-Gable* is a sub-style of the Colonial Craftsman. This home is covered by a gabled roof which has had its gable point “clipped off.” The roof can be front, side or cross-gabled. Typically this type of Craftsman is a one-story building. Sometimes the clipped-gabled roof will have gabled, hipped or eyebrow dormers.

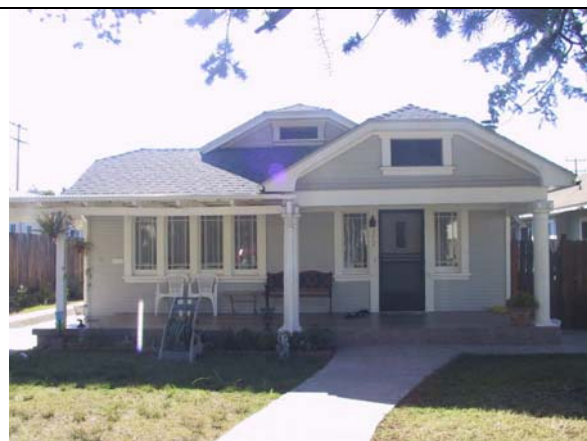
Figure 25: 372 W. Lexington Drive (built in 1921)

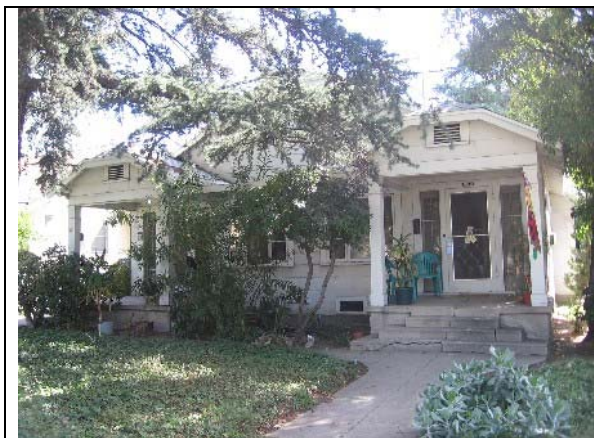
Figure 26: 366 and 368 Burchett Street
(built in 1923)

This is a Craftsman building designed with separate complete living spaces to accommodate more than one household. Within the survey area, multi-family Craftsman buildings are primarily duplex, although there are multiplex examples. These properties boast the character defining features of their single-family residential counterparts. Figure 26, for example, shows a duplex that has the same character defining features as a Clipped-Gable Colonial Craftsman. This includes not only the clipped front gables, which are located above each of the entries, but also the symmetry and Tuscan order columns of that sub-style. Many duplexes are one-story in height, modest in size and scale and each unit generally has one bedroom. Figure 27, however, shows an example that is more substantial. It is two-stories in height with two bedrooms and two bathrooms per unit. It shares the characteristic of a symmetrical façade with its smaller counterpart. This symmetry allows for each unit to be identical to the other.

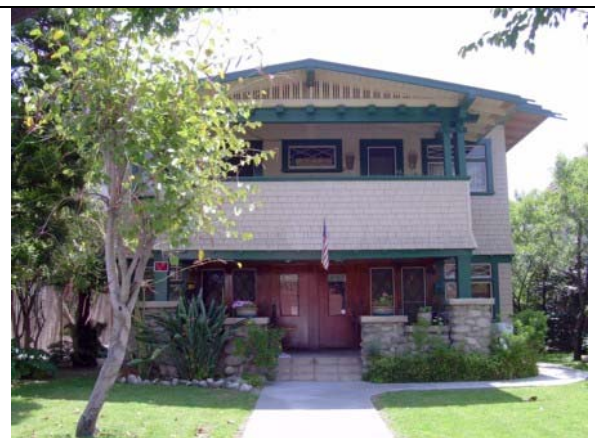
Figure 27: 224 N. Louise Street (built in
1914)

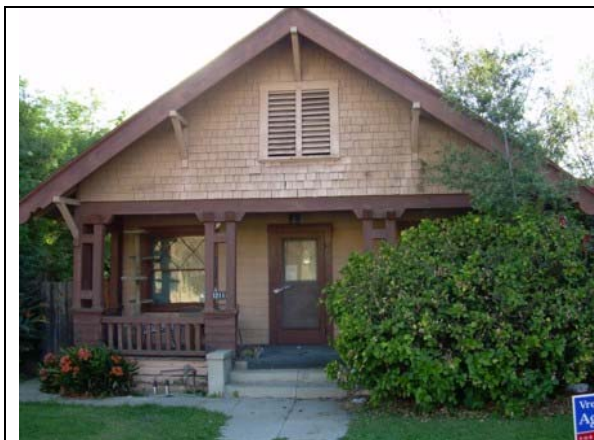
Figure 28: 1211 Viola Avenue (built in 1909)

Typically, the Transitional still retains a strong vertical emphasis on the façade, and Victorian-era design elements such as bay windows, long narrow windows and decorative knee brackets and rafters. In the case of the residence in Figure 28, the paneled front door is Victorian in style, with a single light and dentil details at the top section. The home in Figure 29 also has a window with a Gothic Revival pattern. What generally differentiates this type of residence from a Victorian-era residence is its Craftsman features such as stonework on porch pedestals, horizontally-oriented windows surrounded by wide casings, sometimes a hipped roof with a squat dormer at the façade side of the roof, and rafter tails under the roof line.

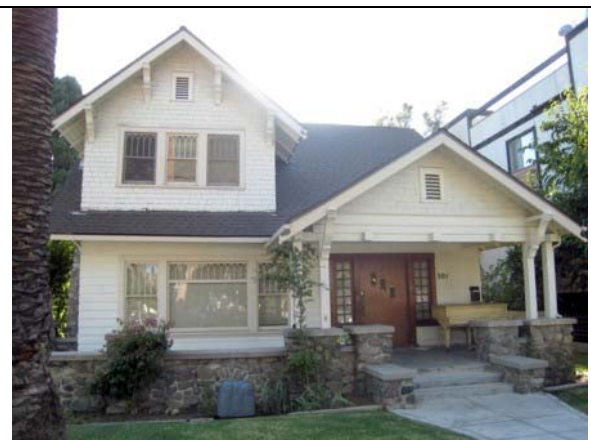
Figure 29: 301 N. Kenwood Street (built in 1911)

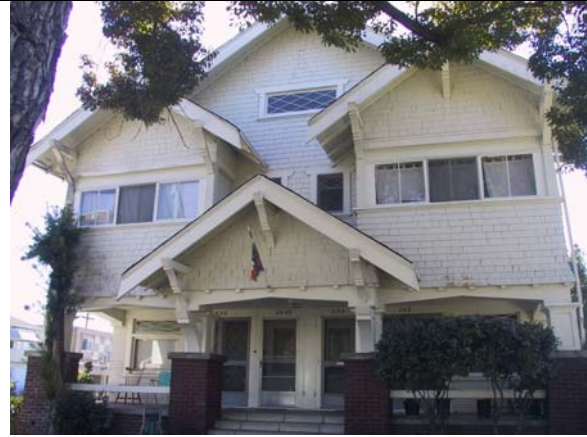
Figure 30: 500-02 W. Wilson Avenue (built in 1914)

Figure 30 is an example of a Craftsman multi-unit apartment building, which has four units total. This is a rare resource in the study area where most of the Craftsman multi-family residences are duplexes. Like the duplexes, this residence also has a symmetrical façade.

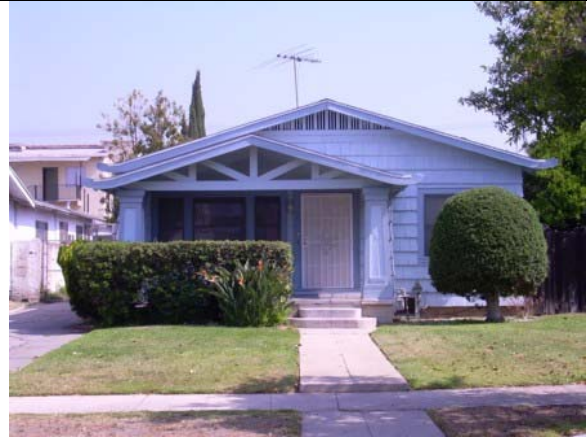
Figure 31: 623 E. Chestnut Street (built in 1921)

diamond patterned window sash located within the top center gable. Figure 31 is an example of a Craftsman residence with Oriental influences, with its upturned eave ends.

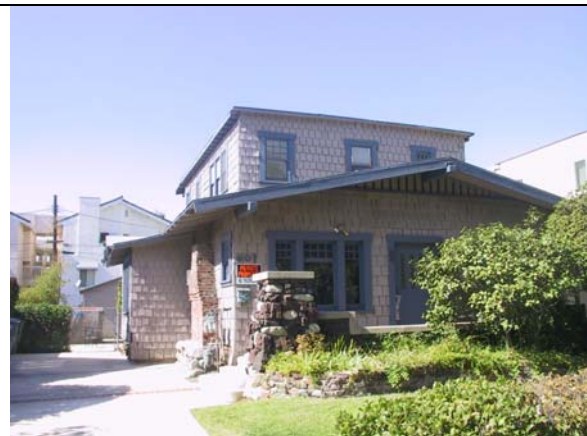
Figure 32: 607 N. Isabel Street (built in 1924)

The Aeroplane is perhaps the most distinctive of the Craftsman sub-styles represented in the city, although there are not many examples. It is not only uncommon in this city, but also throughout Southern California and the rest of the country. This is a style characterized by a set-back second-story, low-pitched roofline, and wide overhanging eaves giving the impression of airplane wings. This residence can have a front, side or cross-gabled roof. The examples in Figures 22 and 23 are front gabled; the residence in Figure 33 is perhaps more iconic with its double front gables and elaborate porch design.

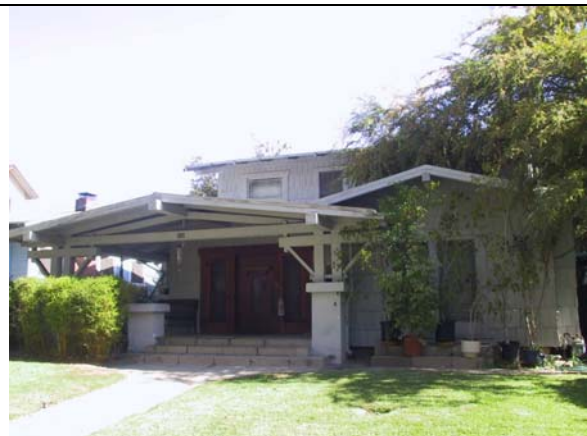
Figure 33: 534 N. Kenwood Street (built in 1913)
